Central Missouri Inspection Services

## SAMPLE REPORT

1234 Main Street  
Jefferson City MO,  
65101

1/29/2026 9:00AM

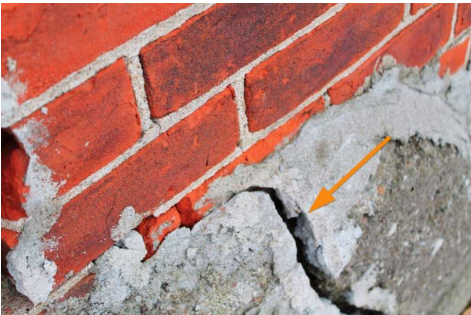
2.1.1 Foundation, Basement & Crawlspaces

FOUNDATION CRACKS - MINOR

SOUTH EXTERIOR

Minor cracking was noted at the foundation. This is common as concrete ages and shrinkage surface cracks are normal. Recommend monitoring for more serious shifting/displacement.

Contact a qualified professional.

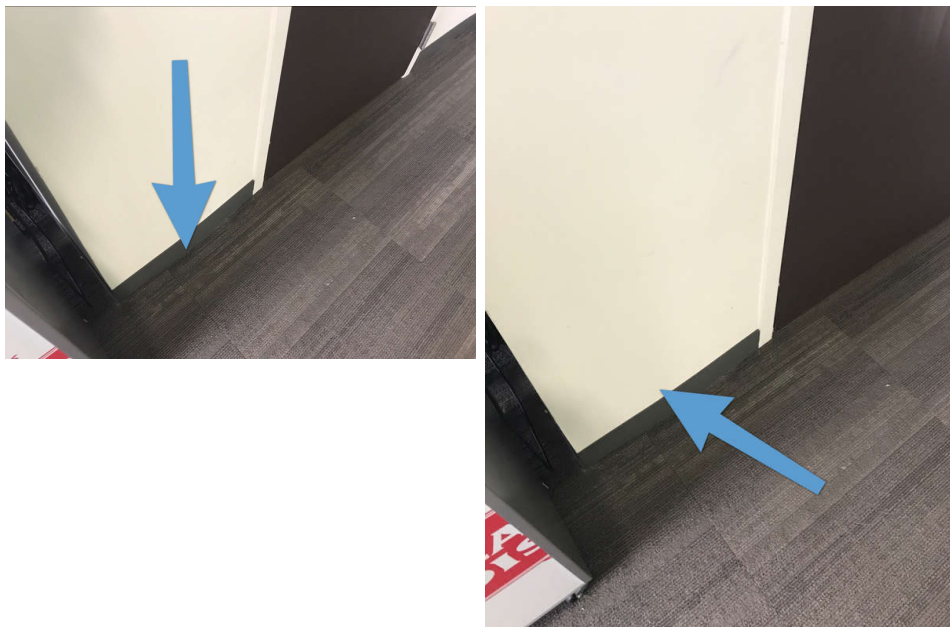
2.3.1 Wall Structure

CRACKS - MINOR

DINING ROOM, LIVING ROOM

Minor cracking was observed in wall structure. This is common in homes this age. Recommend monitoring.

Recommended DIY Project

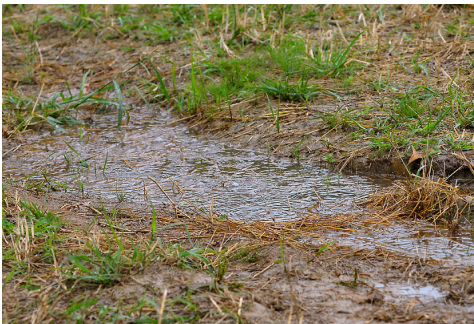
3.5.1 Vegetation, Grading, Drainage & Retaining Walls

**STANDING WATER**

Standing water observed, which could indicate poor drainage and/or grading. Recommend monitor and/or have landscaper correct.

Water pooling in yard; recommend drainage

Contact a qualified landscaping contractor

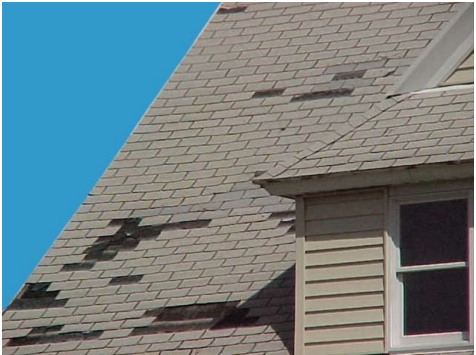
4.1.1 Coverings

**SHINGLES MISSING**  
SOUTH FACING  
Observed areas that appeared to be missing sufficient coverings. Recommend qualified roofing contractor evaluate & repair.  
Recommendation  
Contact a qualified roofing professional.

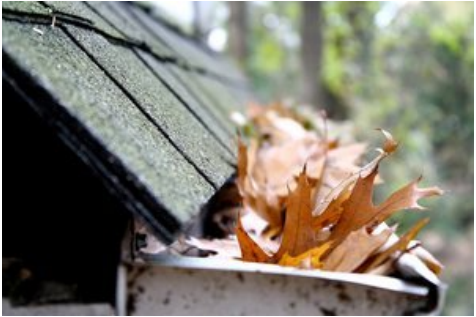
4.2.1 Roof Drainage Systems

**DEBRIS**  
Debris has accumulated in the gutters. Recommend cleaning to facilitate water flow.  
[Here is a DIY resource](#) for cleaning your gutters.  
Recommendation  
Contact a qualified roofing professional.

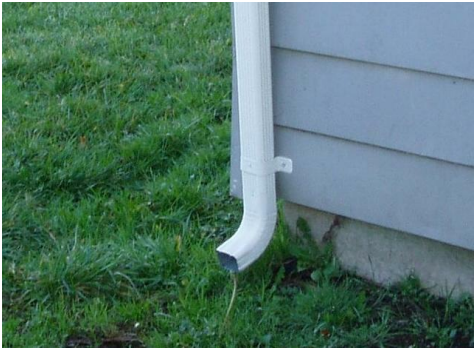
4.2.2 Roof Drainage Systems

**DOWNSPOUTS DRAIN NEAR HOUSE**  
One or more downspouts drain too close to the home's foundation. This can result in excessive moisture in the soil at the foundation, which can lead to foundation/structural movement. Recommend a qualified contractor adjust downspout extensions to drain at least 6 feet from the foundation.  
[Here is a helpful DIY link](#) and video on draining water flow away from your house.  
Recommendation  
Contact a qualified roofing professional.

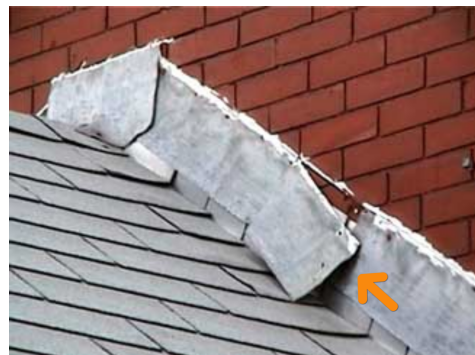
## 4.3.1 Flashings

**LOOSE/SEPARATED**

Flashings observed to be loose or separated, which can lead to water intrusion and/or mold. Recommend a qualified roofing contractor repair.

Contact a qualified roofing professional.

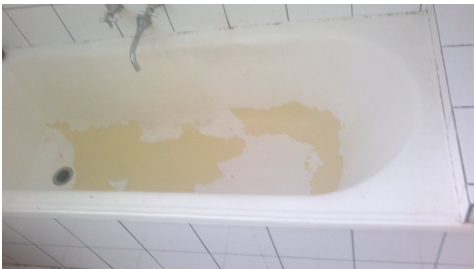
5.1.1 Fixtures / Faucets

**BATHTUB PAINT PEELING**  
Bathtub paint is peeling off. Recommend replacement or qualified repair.

Contact a qualified professional.

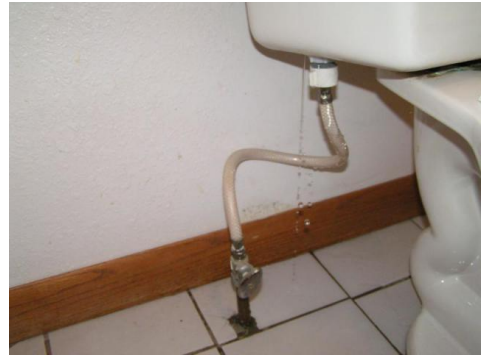
## 5.1.3 Fixtures / Faucets

**TOILET LEAKING**

Toilet is dripping near water supply. Recommend qualified handyman or plumber repair.

Contact a qualified plumbing contractor.

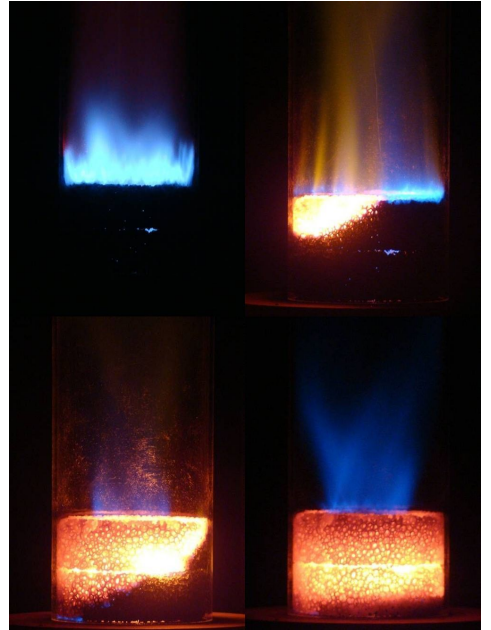
## 5.3.1 Water Heater

**IRREGULAR FLAME**

Water heater flame is irregular. Recommend qualified plumber evaluate & repair.

Contact a qualified plumbing contractor.

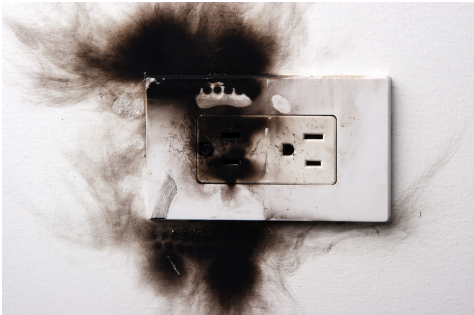
6.4.1 Connected Devices and Fixtures (Representative number of switches and receptacles in the home, garage & exterior)

### COVER PLATES DAMAGED

One or more receptacles have a damaged cover plate. Recommend replacement.

Scorch marks on cover plate

Contact a qualified electrical contractor.

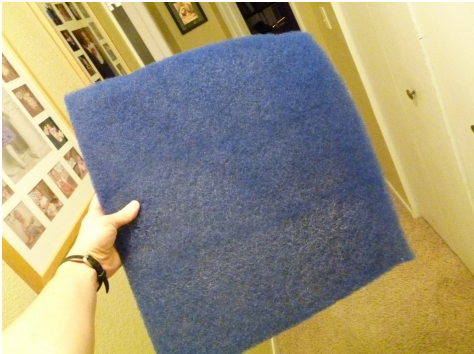
### 7.1.1 Heating Equipment

#### **FILTER REQUIRES REPLACEMENT**

The furnace filter appears to be beyond its expected lifespan. Recommend replacement.

Contact a qualified HVAC professional.

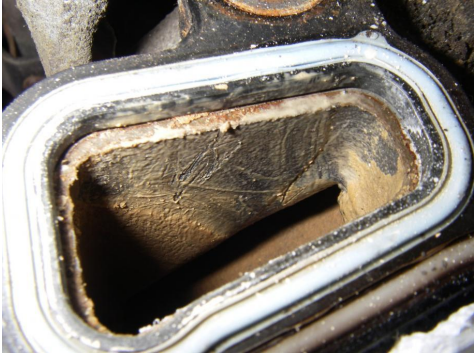
### 7.1.2 Heating Equipment

#### **MANIFOLDS DIRTY**

Cleaning manifolds will result in better air quality.

Contact a qualified HVAC professional.

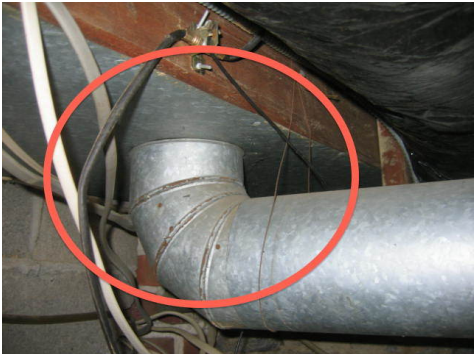
8.2.1 Distribution System

**LOOSE CONNECTION**

There are loose connections on ducts, resulting in energy loss. Recommend licensed HVAC contractor resecure.

Loose connection; recommend sealing.

Contact a qualified HVAC professional.

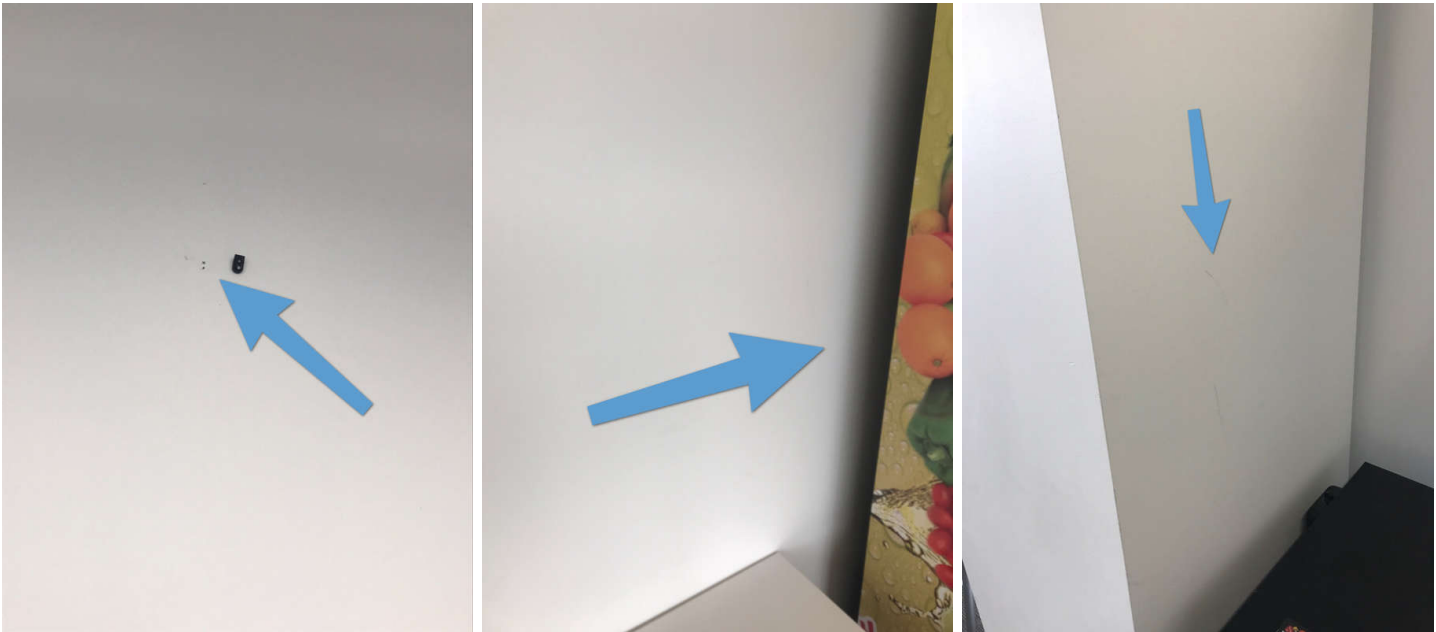
9.1.1 Walls

**POOR PATCHING**  
Sub-standard drywall patching observed at time of inspection. Recommend re-patching.  
Recommendation  
Contact a qualified drywall contractor.

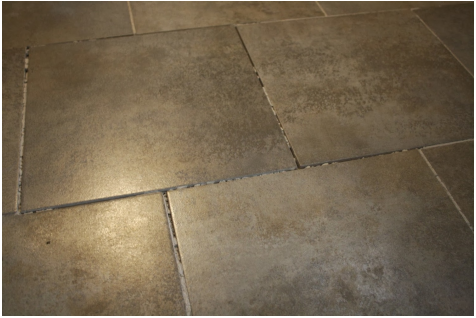
9.3.2 Floors

**TILES LOOSE**

Loose tiles are present. Recommend re-attach and seal.

Recommendation  
Contact a qualified flooring contractor

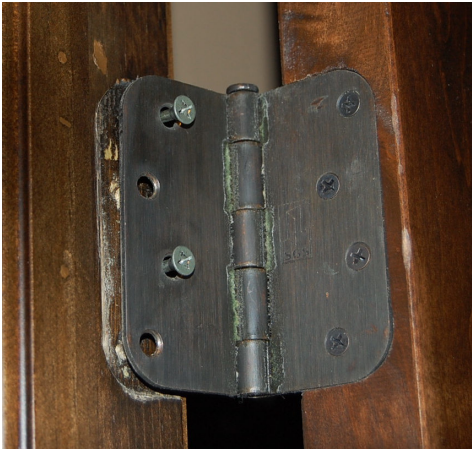
9.6.1 Doors (Representative number)

**HINGES LOOSE**

Loose hinges can cause door to stick or eventually fall out of place. Recommend handyman tighten hinges.

Recommendation  
Contact a qualified handyman.

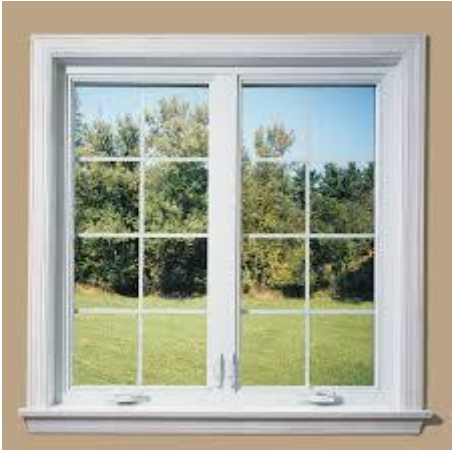
9.7.1 Windows (Representative number)

**MISSING SCREEN**

Window missing screen. Recommend replacement.

Contact a qualified window repair/installation contractor.

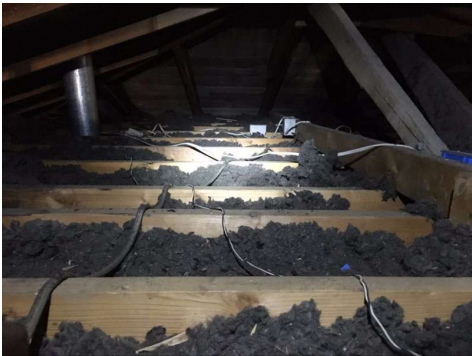
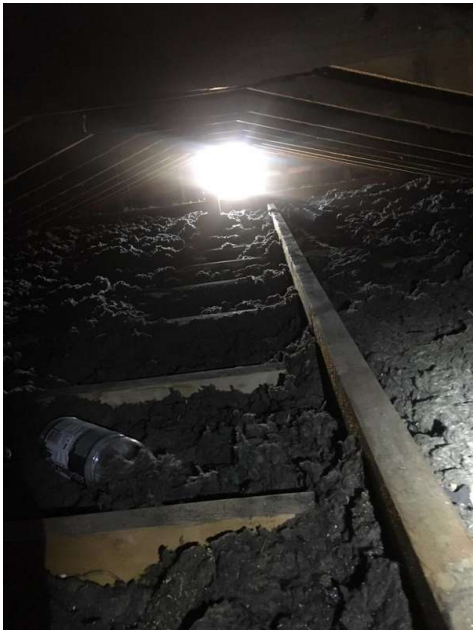
### 11.1.1 Attic Insulation

#### INSUFFICIENT INSULATION

Insulation depth was inadequate. Recommend a qualified attic insulation contractor install additional insulation.

Recommendation  
Contact a qualified insulation contractor.

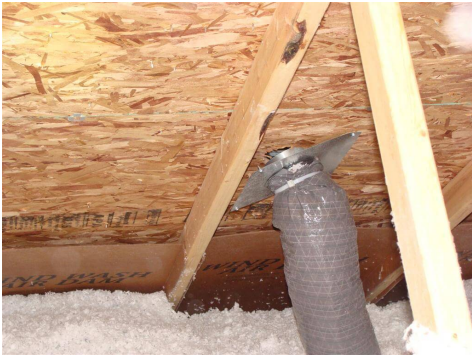
### 11.4.1 Exhaust Systems

#### DUCTS LOOSE

Ductwork in the attic is loose or disconnected. Recommend repair.

Recommendation  
Contact a qualified HVAC professio

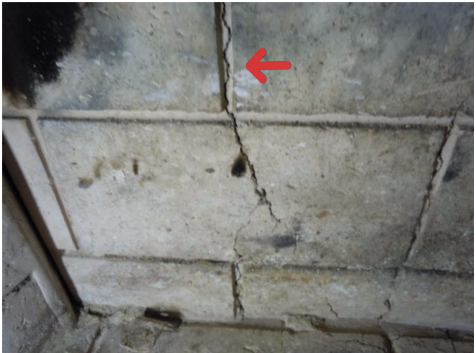
12.1.1 Fireplaces, Stoves & Inserts

**FIREWALL CRACKED**

The brick lining of the fireplace was cracked in one or more places, which could lead to chimney damage or toxic fumes entering the home. Recommend a qualified fireplace contractor evaluate and repair.

Contact a qualified fireplace contractor.
